OH-58 Pilot Display Unit (PDU) Simulated Crash Tests

December 1994

**United States Army Aeromedical Research Laboratory
Fort Rucker, Alabama 36362-0577**

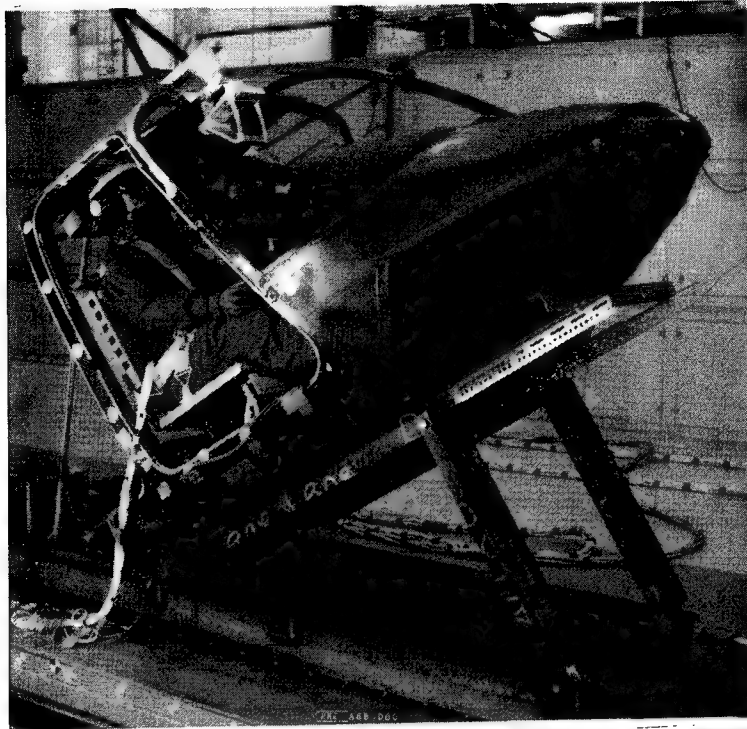
The setup for test 88060 is shown in Figure 4. As shown in Table 1, this test simulates a pitch down crash in which the vertical force is slightly greater than half the forward force. At 500 G/sec acceleration onset and 15-G peak combined with only 23.5 fps velocity, the impact was of moderate level. As shown in Table 3, the neck tensile force of 444 pounds and 613 inch-pound moment about the lateral (y) axis is about half that of the values in test 88063. The force transfer into the PDU ½-inch ENSOLITE™* foam from the helmet impact did not register on the neck load cell or the head accelerometers.

Figure 4. Pretest view of no. 88060; note the absence of crashworthy seat cushion and the dummy PDU and mount.

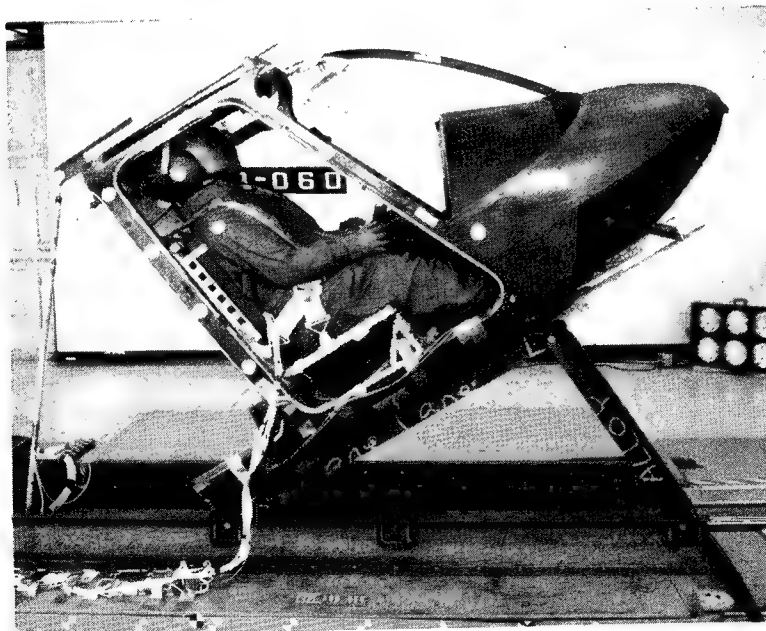
Posttest photos of test 88060 in Figures 4 through 9 show: (a) rotation of helmet rearward on right dummy, but not the left dummy, even though both have equal size 50th percentile heads; the difference may be due to the lack of neck flesh on the Hybrid II (50th percentile) dummy; and (b) the left seat crashworthy seat pan sustained enough downward force from the dummy's buttocks to move the pan down 0.6 inch, and to move the right seat down by 0.3 inch. This was a surprise since the impact vector was 15 G forward, and the seat pans stroke at 12 G vertical. The right seat pan was secured with steel straps to prevent movement in subsequent tests.

Figure 5. Posttest view of no. 88060; note the rearward rotation of helmet after rebound.

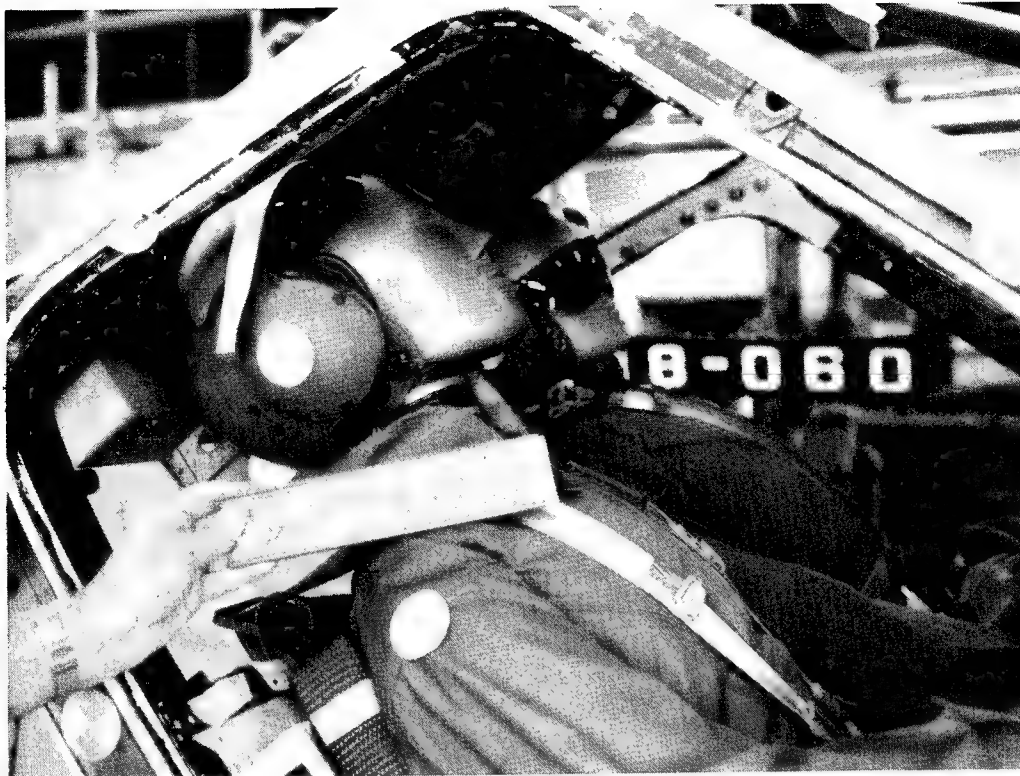
Figure 6. Posttest view of 50th percentile dummy; note helmet rotated until stopped by nape strap.

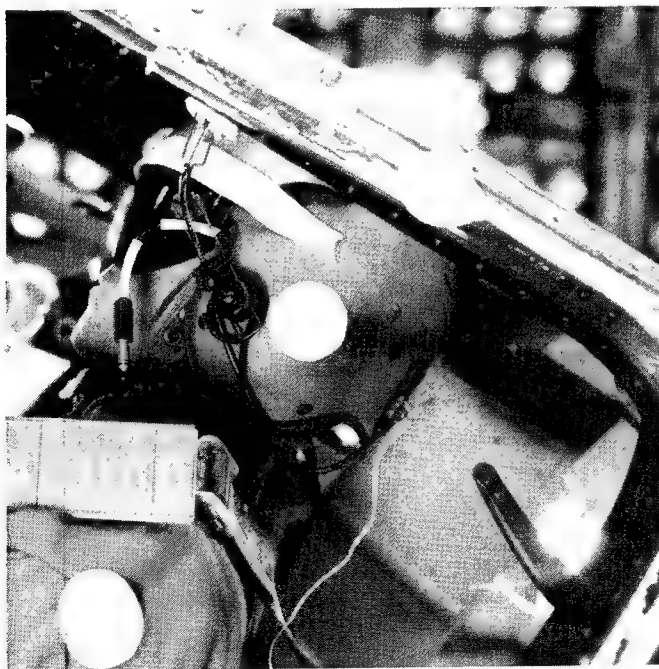
Figure 7. Posttest view of 95th percentile dummy in left seat.

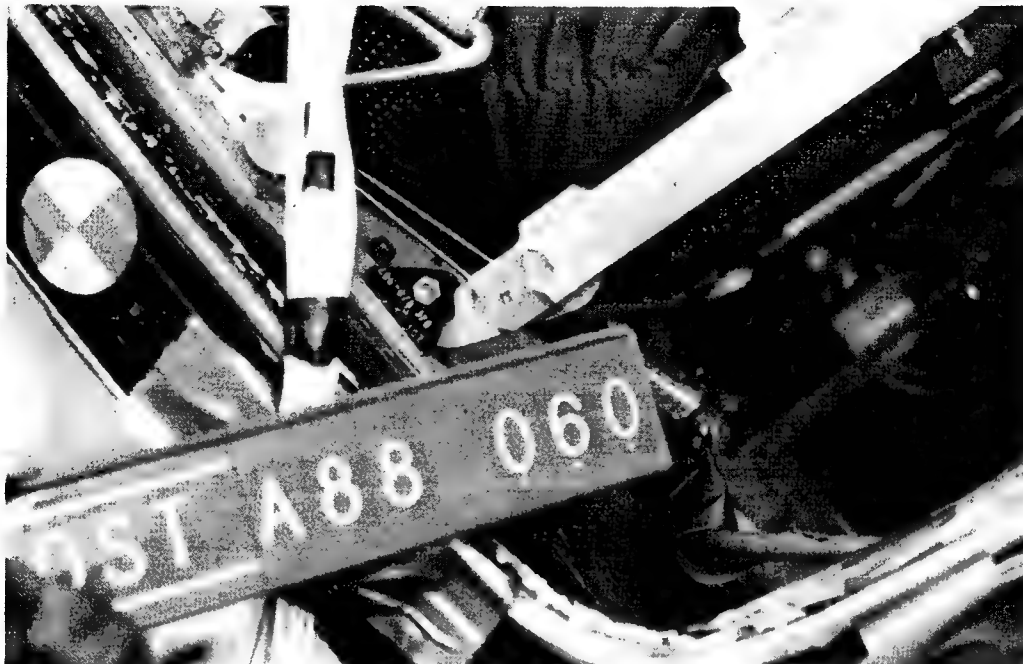
Figure 8. Seat pan downward displacement of 0.3 inch shown between latch and bulkhead support, right side.

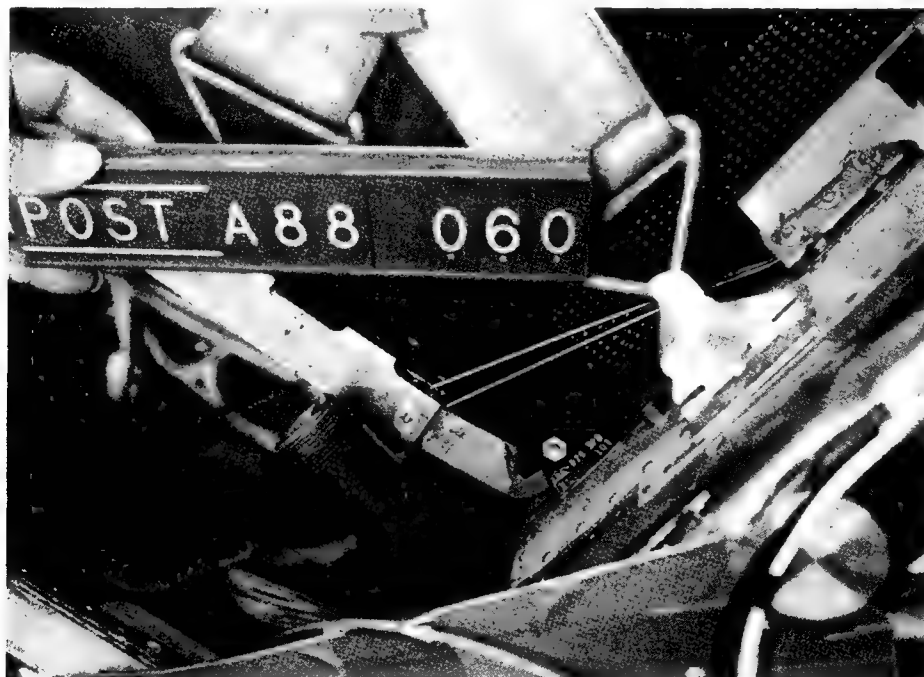
Figure 9. Seat pan downward displacement of 0.6 inch shown between latch and bulkhead support, left side.

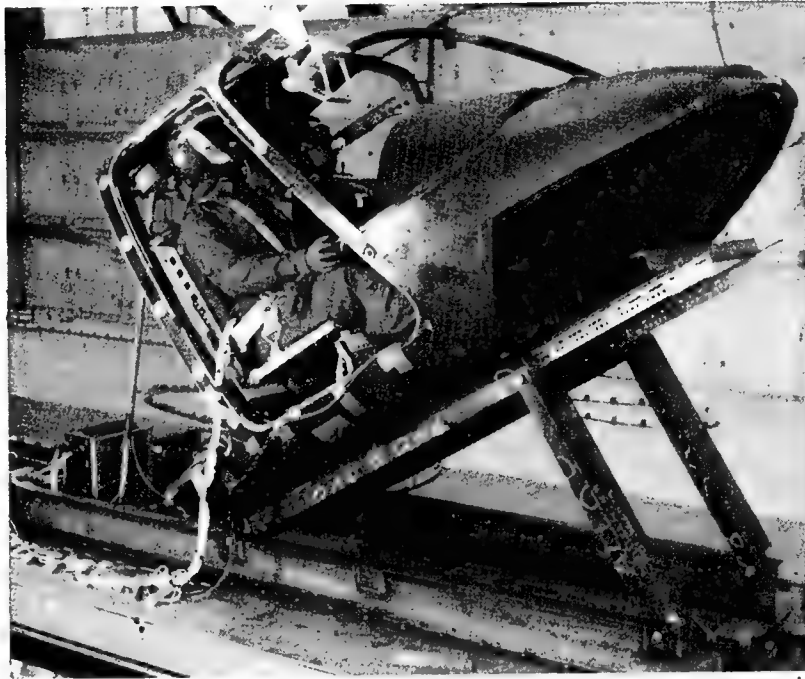
The setup is shown in Figure 10, the straps to secure the right seat are shown along with the reinforcement of the left forward door bulkhead. The posttest photo is at Figure 11.

Figure 10. Pretest view of CAMI 88061; note aluminum strap on inside of left door frame and steel strap on right seat.

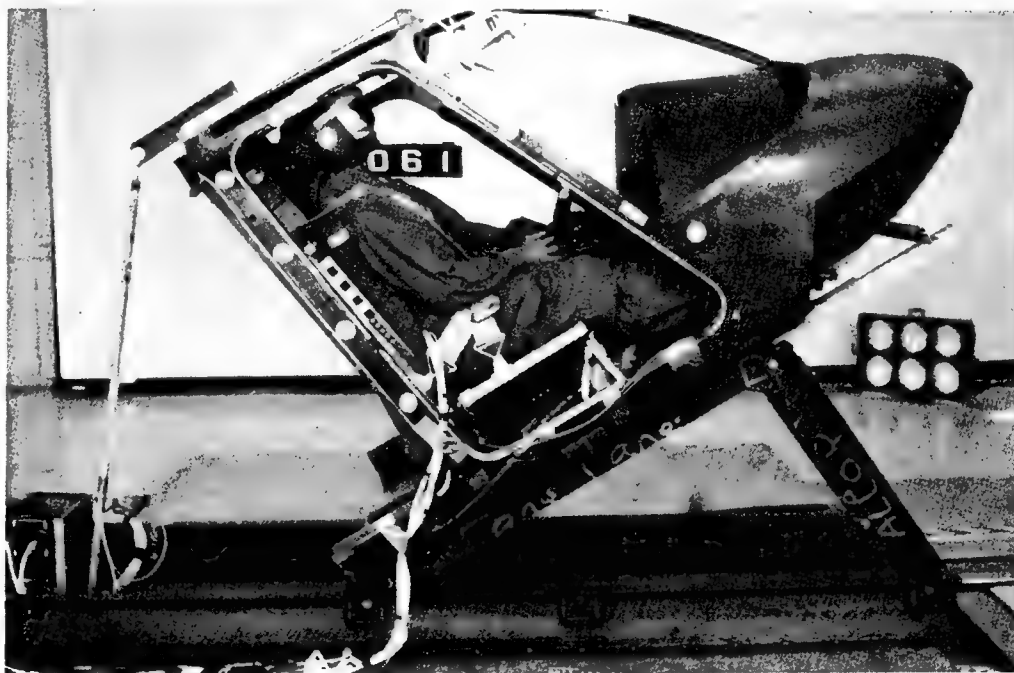
Figure 11. Posttest view of CAMI 88061; note that helmet has not rotated due to tape under chin.

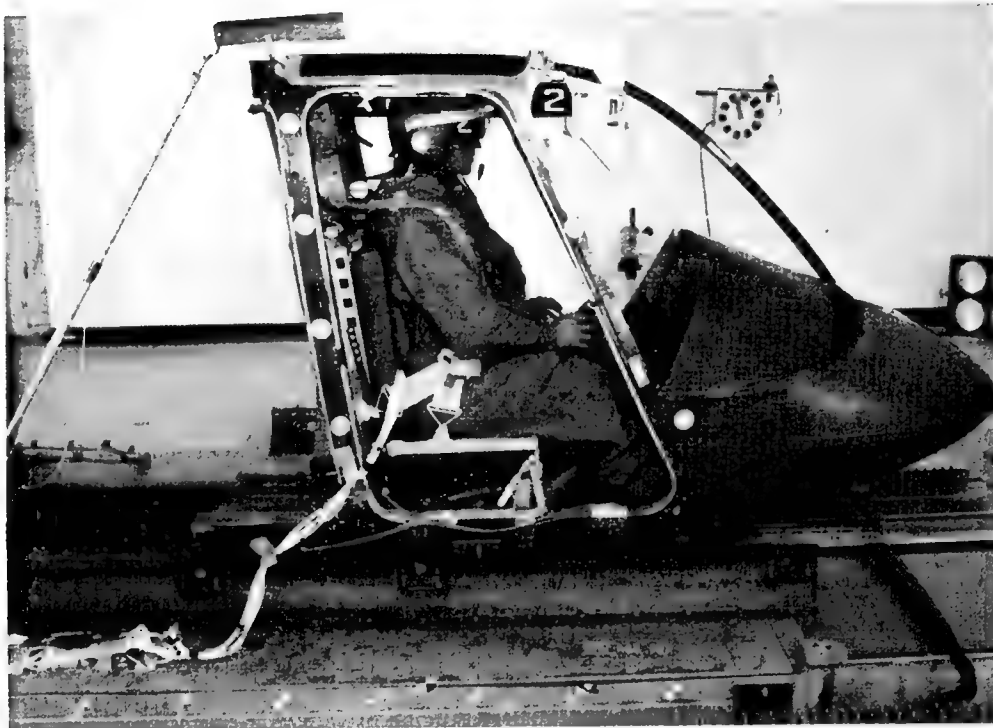
Figure 14. Posttest view of no. 88062; note rebound position of sled about 1 foot from displaced $\frac{1}{4}$ -inch diameter cable.

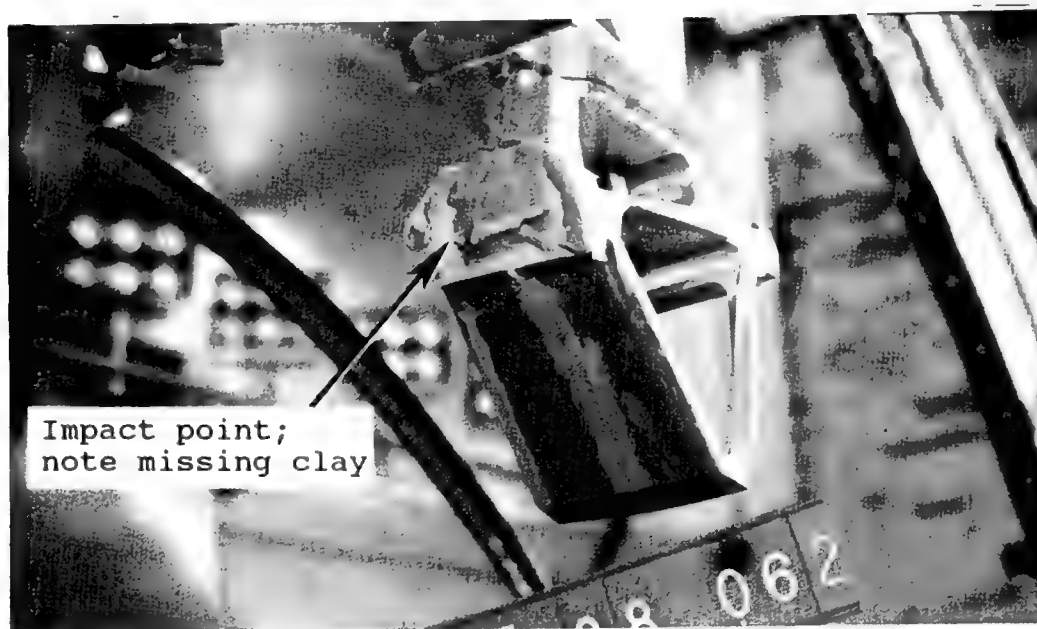
The helmet was replaced after this test due to permanent foam compressive "set" of about 0.05 inch over an area of about 1 square inch in the lower front edge of the foam liner. The foam replacement is required to obtain the full energy-absorbing benefit of the foam liner if impacted again at the same location. The impact location onto the PDU is shown in Figure 15.

Figure 15. Posttest view of no. 88062; note missing clay which was found on helmet of right dummy.

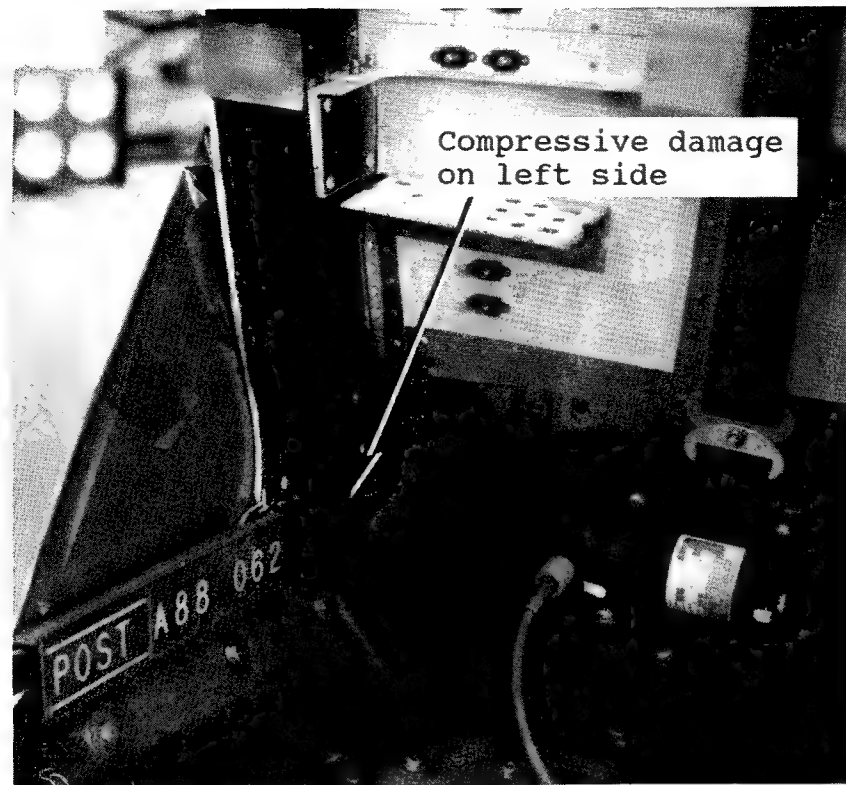
The fuselage station (FS) 73.04 bulkhead was damaged by skin crippling/buckling at the lower outboard edges and at the control "closet" box structure as shown in Figures 16-18. The bulkhead was reinforced prior to the final tests.

Figure 16. Posttest of no. 88062; note buckled "box" section of fuselage station 73.04 bulkhead.

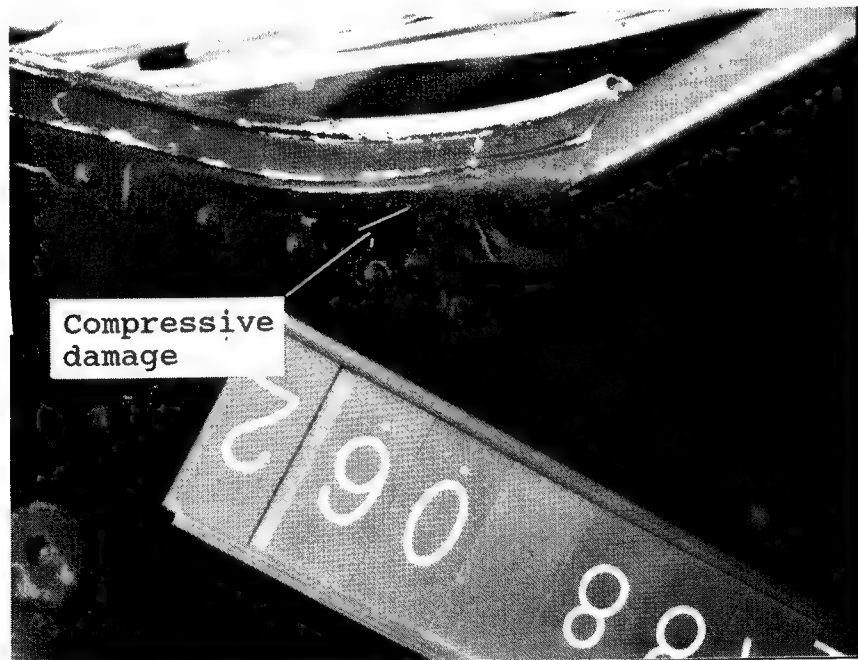
Figure 17. Posttest view of no. 88062; note buckled skin adjacent to "box" section of fuselage station 73.04 bulkhead.

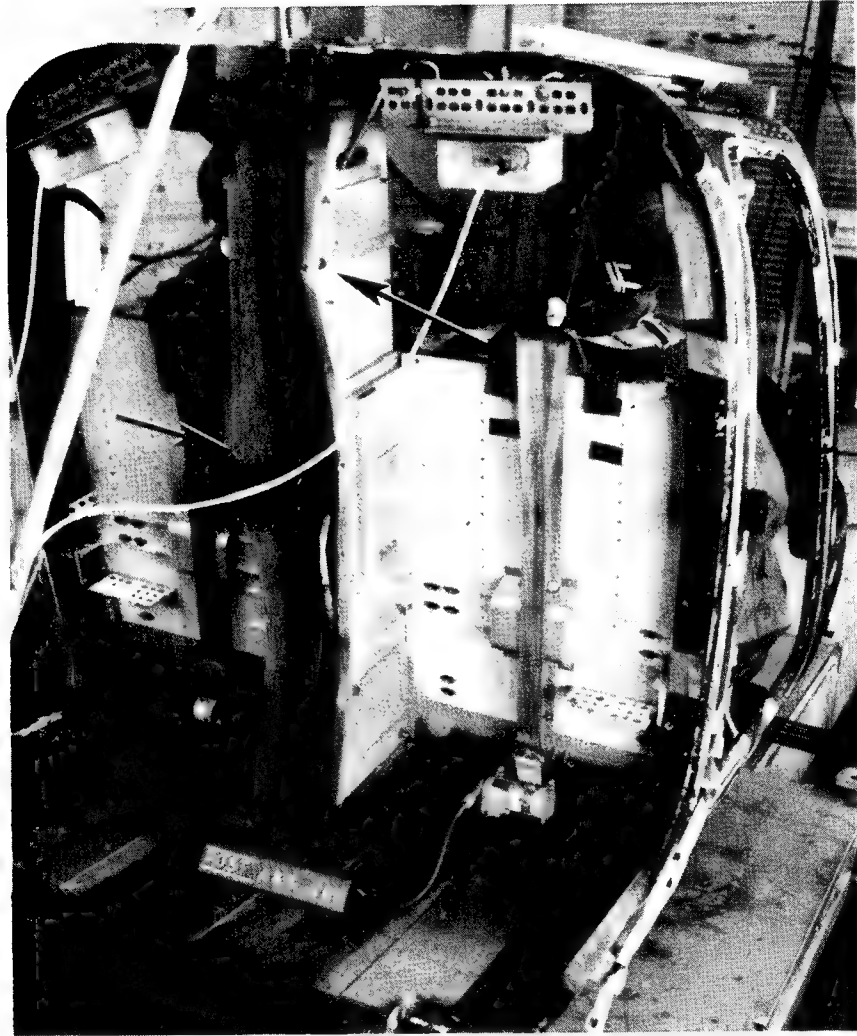
Figure 18. Posttest view of fuselage station 73.04 bulkhead; note buckles in control closet structure by arrows.

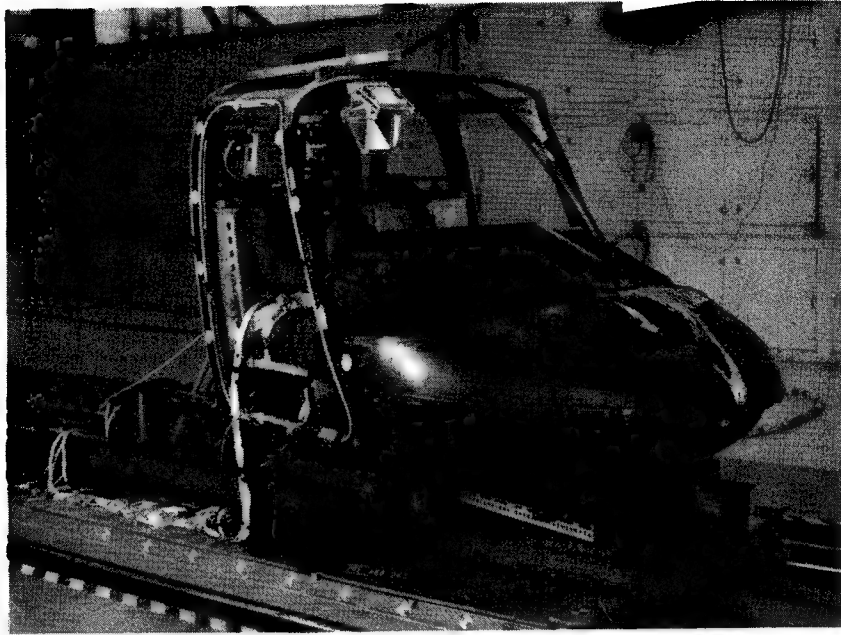
Figure 19. Pretest view of no. 88063; note 15-degree right yaw orientation, and prior damage to nose structure.

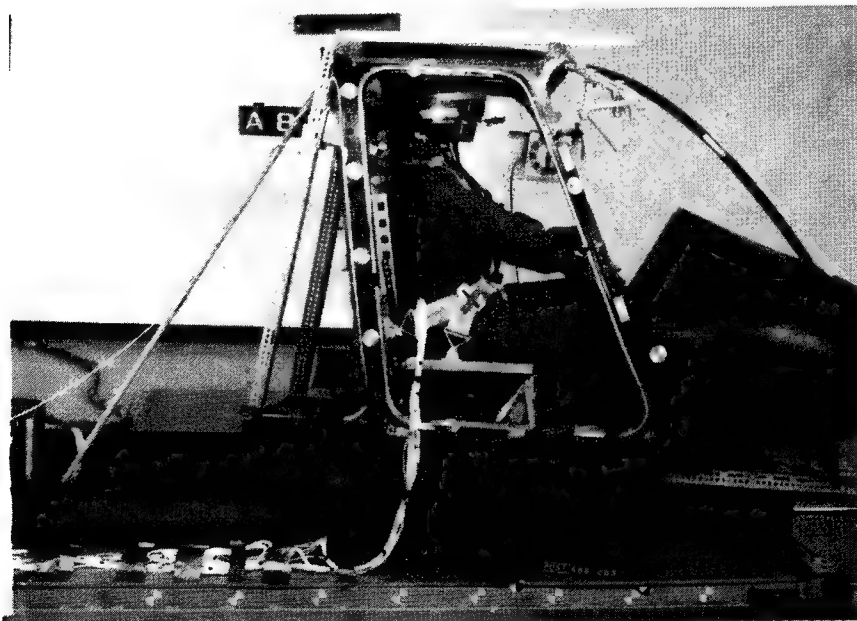
Figure 20. Posttest view of no. 88063; note the actual production PDU mount in place and bulkhead 73.04 reinforcement.

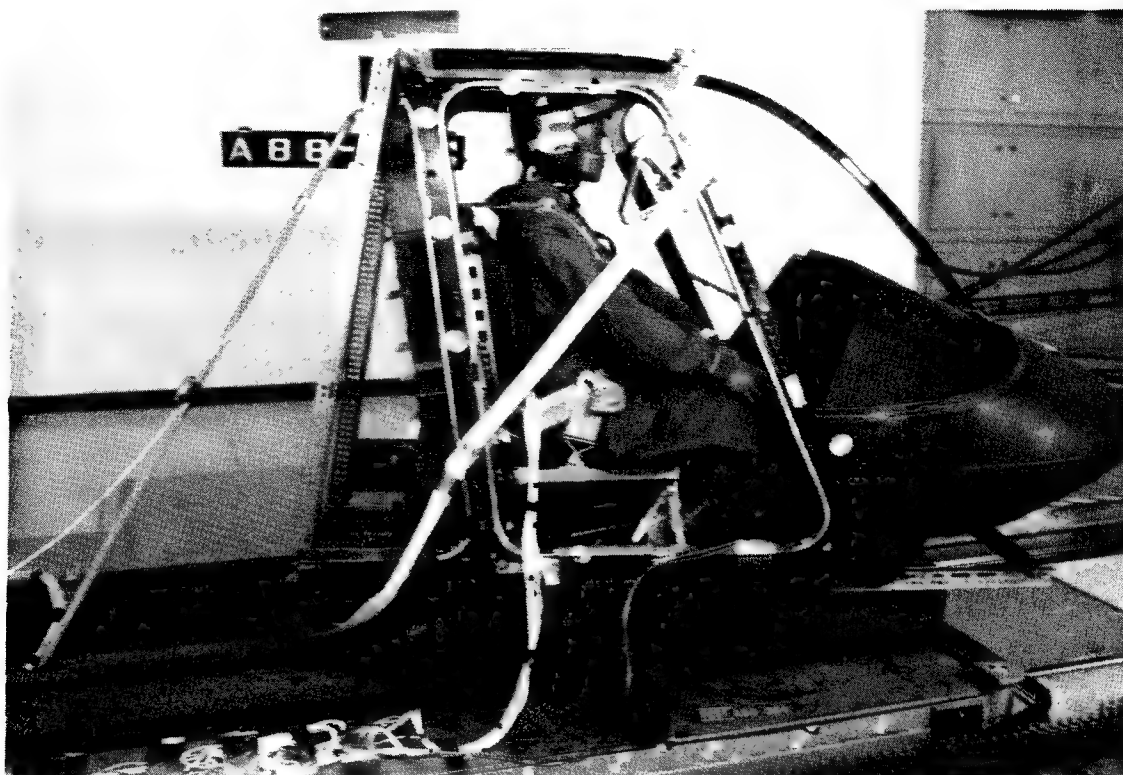
Figure 23. Posttest view of no. 88064; note limp, stretched aluminum diagonal strap, and PDU mount detachment.

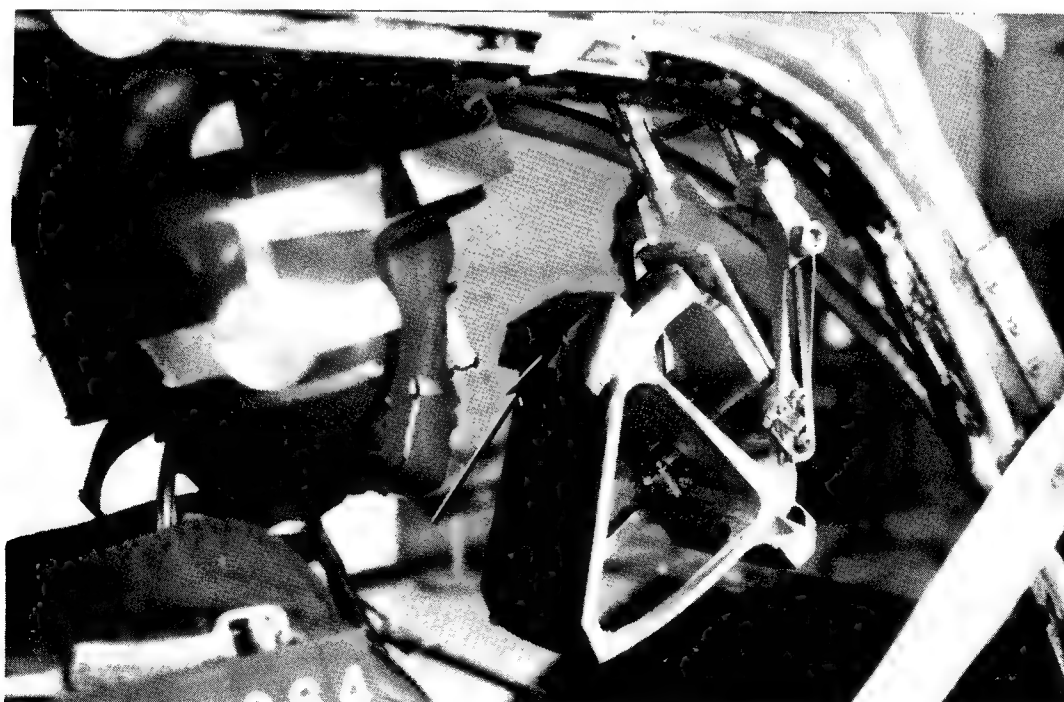
**PDU mount at windshield frame failed partially during rebound, see Fig 24.

Helmet to PDU impact occurred; Figure 31 shows the impact from film analysis. The impact appeared to be severe based on film review since the PDU mount failed at its leading edge rivet attachment to the windshield overhead frame, as depicted in Figures 23, 24, and 26. The impact cracked the helmet visor cover at its center low edge, as shown in Figure 25. The PDU foam also was cracked and the visor cover released the visor knob and visor.

Figure 24. Posttest view of no. 88064; note detached PDU "breakaway" mount and cracked foam at back edge of PDU.

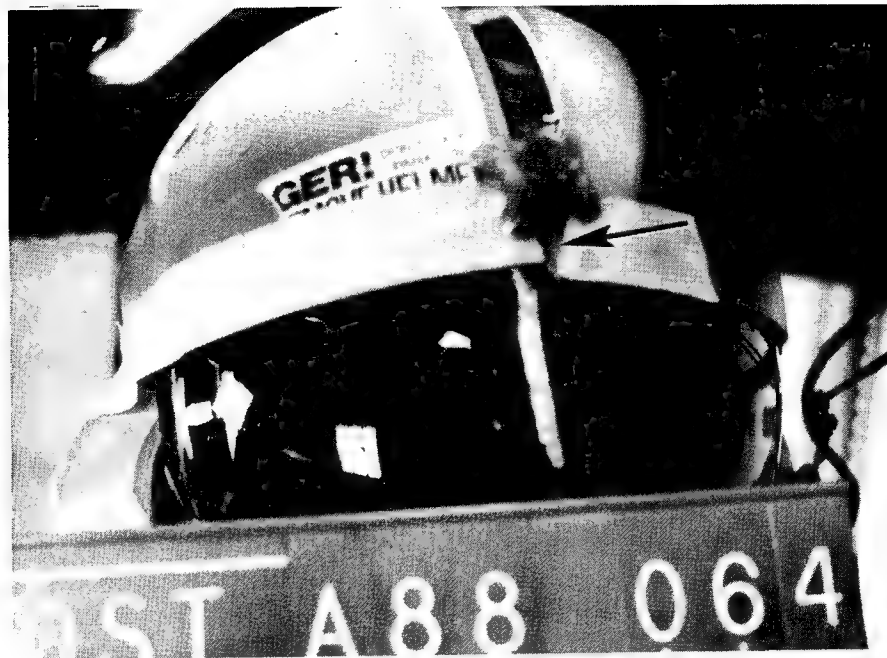
Figure 25. Posttest view of no. 88064; arrow denotes cracked helmet visor cover.

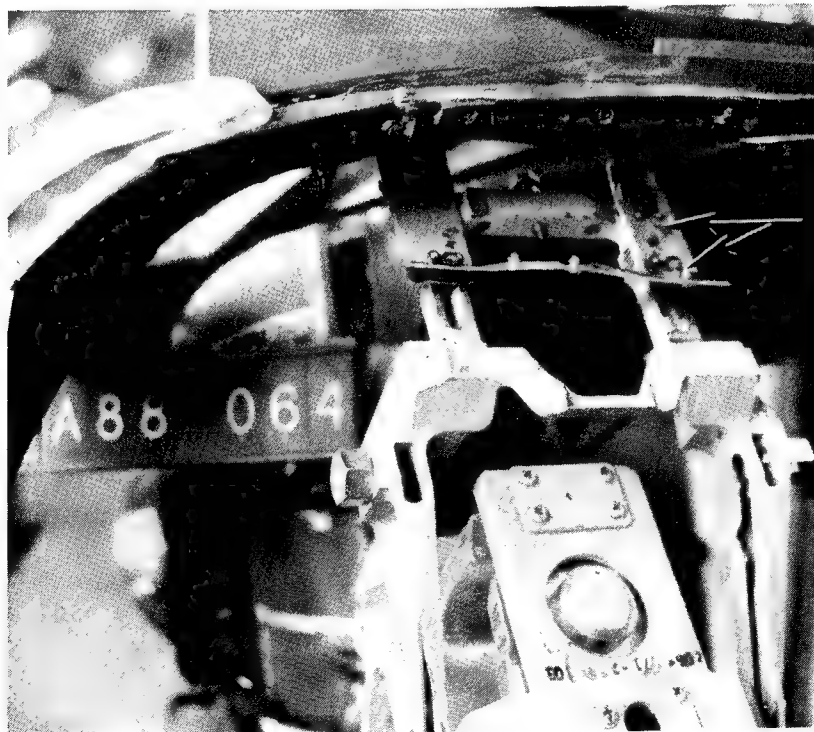
Figure 26. Posttest view of no. 88064; arrow denotes failed rivets which help to secure the PDU breakaway mount.

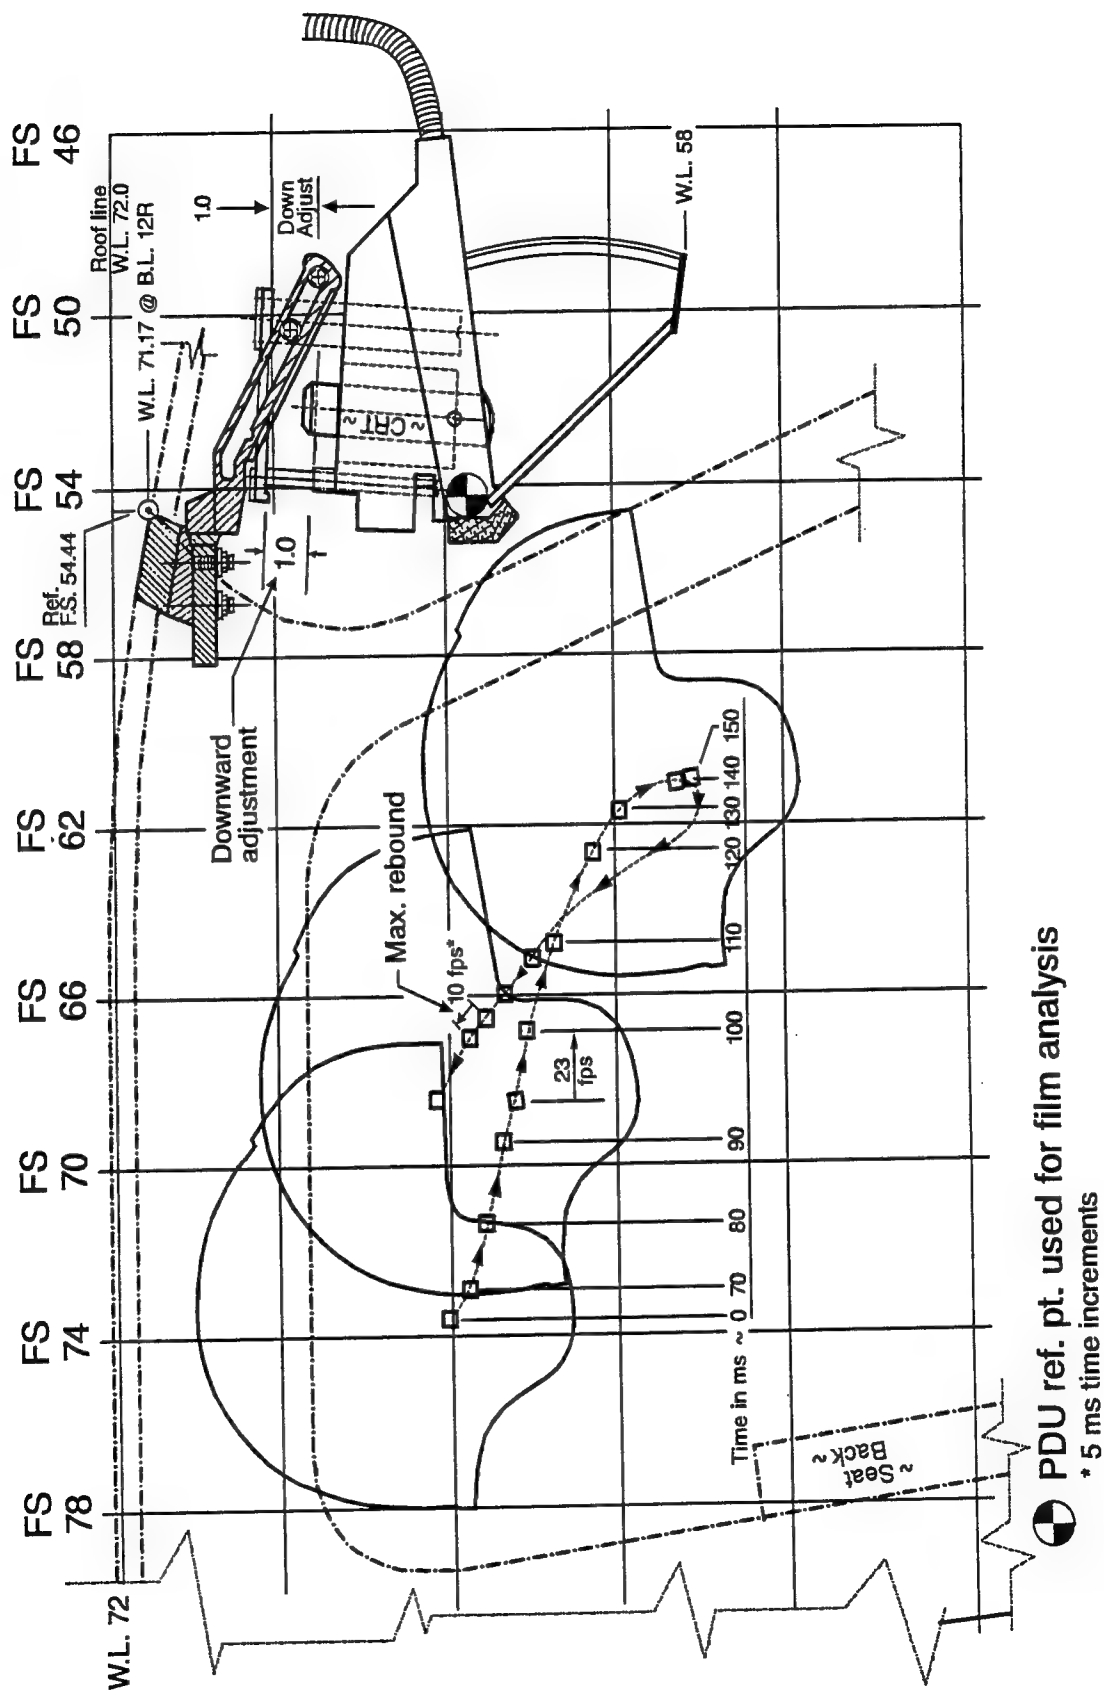
Review of the helmet's movement in Figure 28 shows almost identical movement to the prior test (approximately 13.8 inches in this test, and 13.7 inches in 88060). One would have expected more movement with greater energy and peak G in the sled pulse. It may be the inertia reel locked sooner in the pulse sequence and prevented as much shoulder strap extension. For some unknown reason, the dummy's helmeted head moved downward nearly 6 inches in lieu of 2.1 inches in the identical test 88060; this down movement caused the helmet to almost miss the PDU with only grazing contact. No marks could be seen on the helmet visor cover and no contact is shown by film analysis in Figure 28.

Figure 28. Helmeted head displacement in second 30-degree pitch down test 88061.

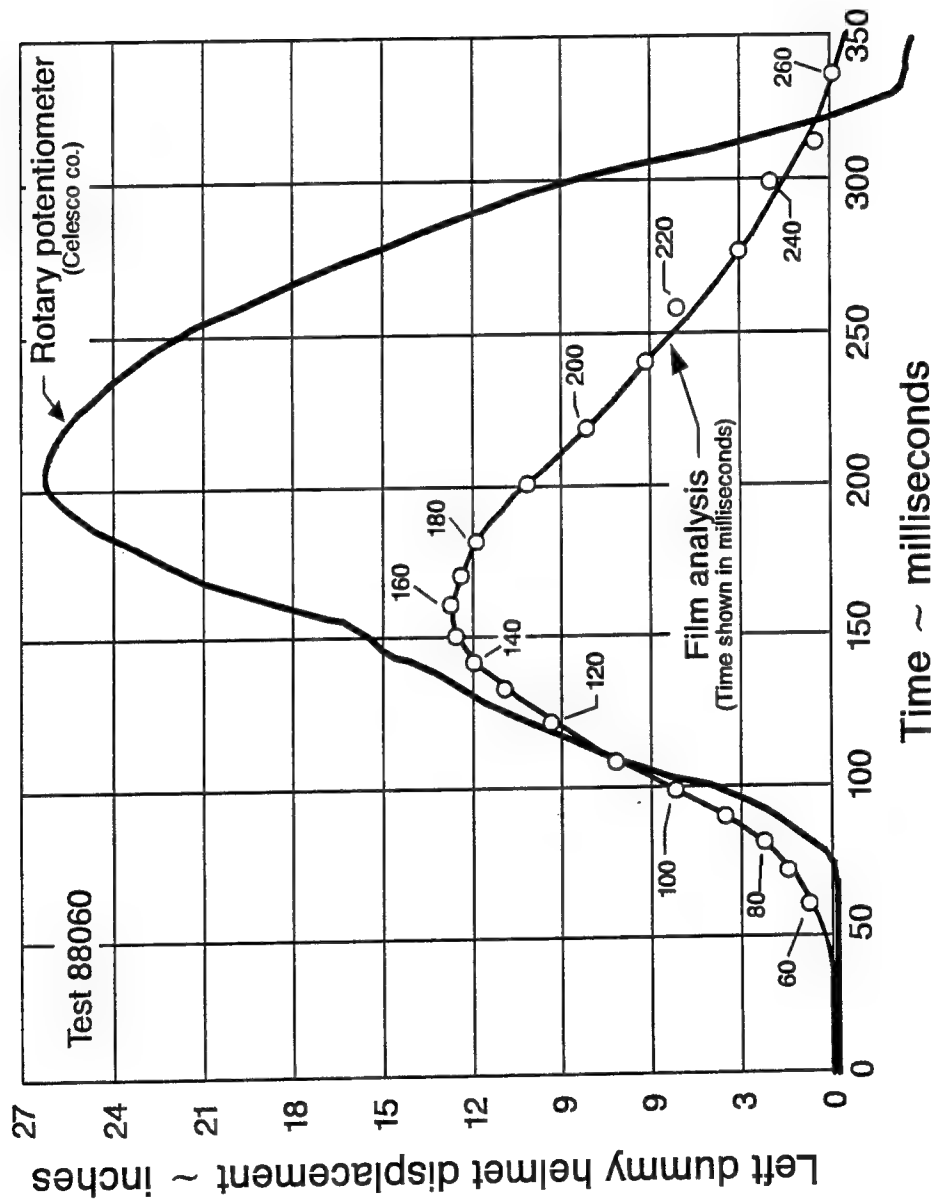
The movement of the helmeted head of the left dummy was recorded by a Celesco potentiometer as shown in figure A-5. the recorded 26-inch value obviously was incorrect based on a cursory film review; the film analysis revealed a movement of 13 inches, half that shown by the potentiometer. Note in Figure A-5 the film showed about 1½-inches of movement before the potentiometer began to rotate (record), and the potentiometer continued to record movement from 15 to 26 inches between 150 and 200 ms. Thus, it is clear the potentiometers on both dummies cannot be used for precise movement data. Discussions with the CAMI test track chief, Mr. Gowdy, indicate the acceleration of the cables from the instruments exceeded the rate limitations of the device. Nonetheless, the first four recordings from the right dummy's helmet are copied and compared in Figure A-2, and all show a similar "overrun" error from 21 to 29 inches. The actual helmeted head movement in all five tests shows movement of 12 to 14 inches. Thus, the film analysis motion is used exclusively in discussing helmet movement in these tests.

Figure A-5. Comparison of left dummy helmet displacement in test 88060: rotary potentiometer vs. film analysis.
